EDGEWATER CONDOMINIUMS OF BROWARD

EWC - BUILDING 16

Uniform Mitigation Verification Inspection Form

BUILDING 16 – ROOF PHOTOS

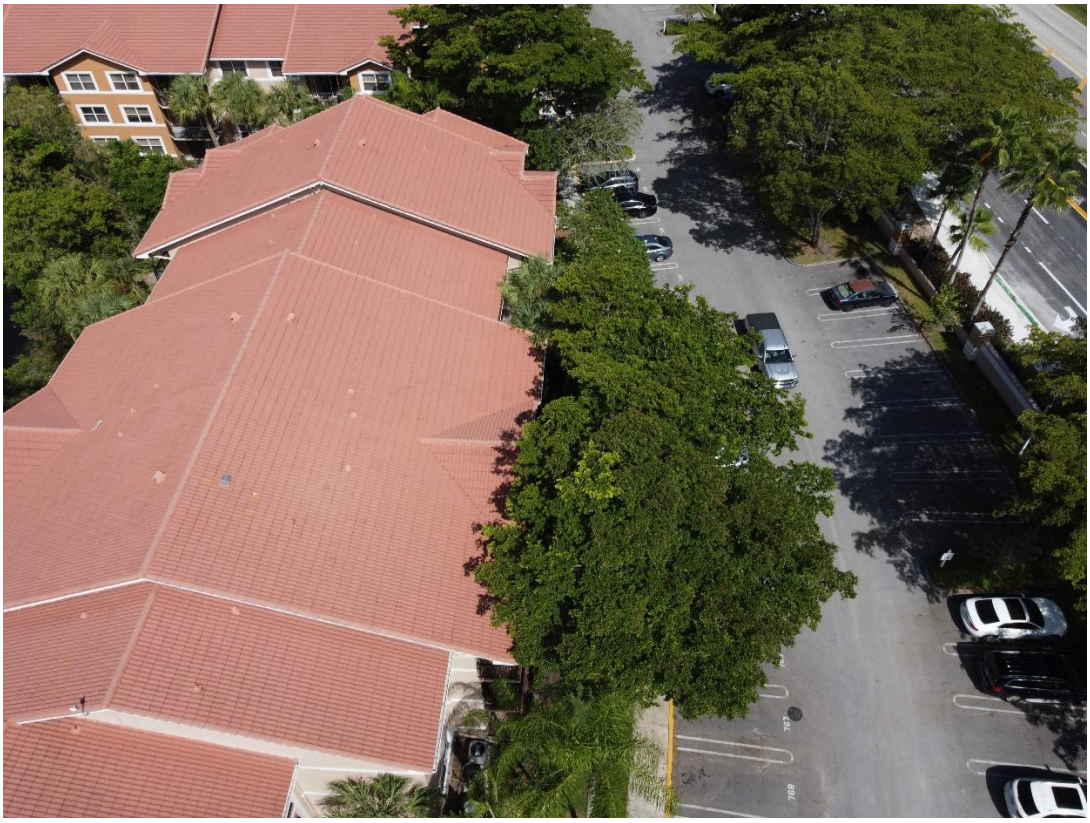
TEAR OFF OLD ROOF - 2013

DURING TEAR OFF - 2013

FELT & DRY IN - 2013

TU POLY-STICK INSTALLATION - 2013

TILE SET - 2013

TILE LOAD AND INSTALL - 2013

SHEATHING NAILS - 2013

STRAP PHOTO - 2013

NAIL SPACING - 2013

NEW ROOF COMPLETE - 2013
